**SUBSIDENCE MONITORING REPORT  
1995  
STAR POINT MINE  
ACT/007/006**

**Cyprus Plateau Mining Corporation  
P.O. Drawer PMC  
Price, Utah 84501**

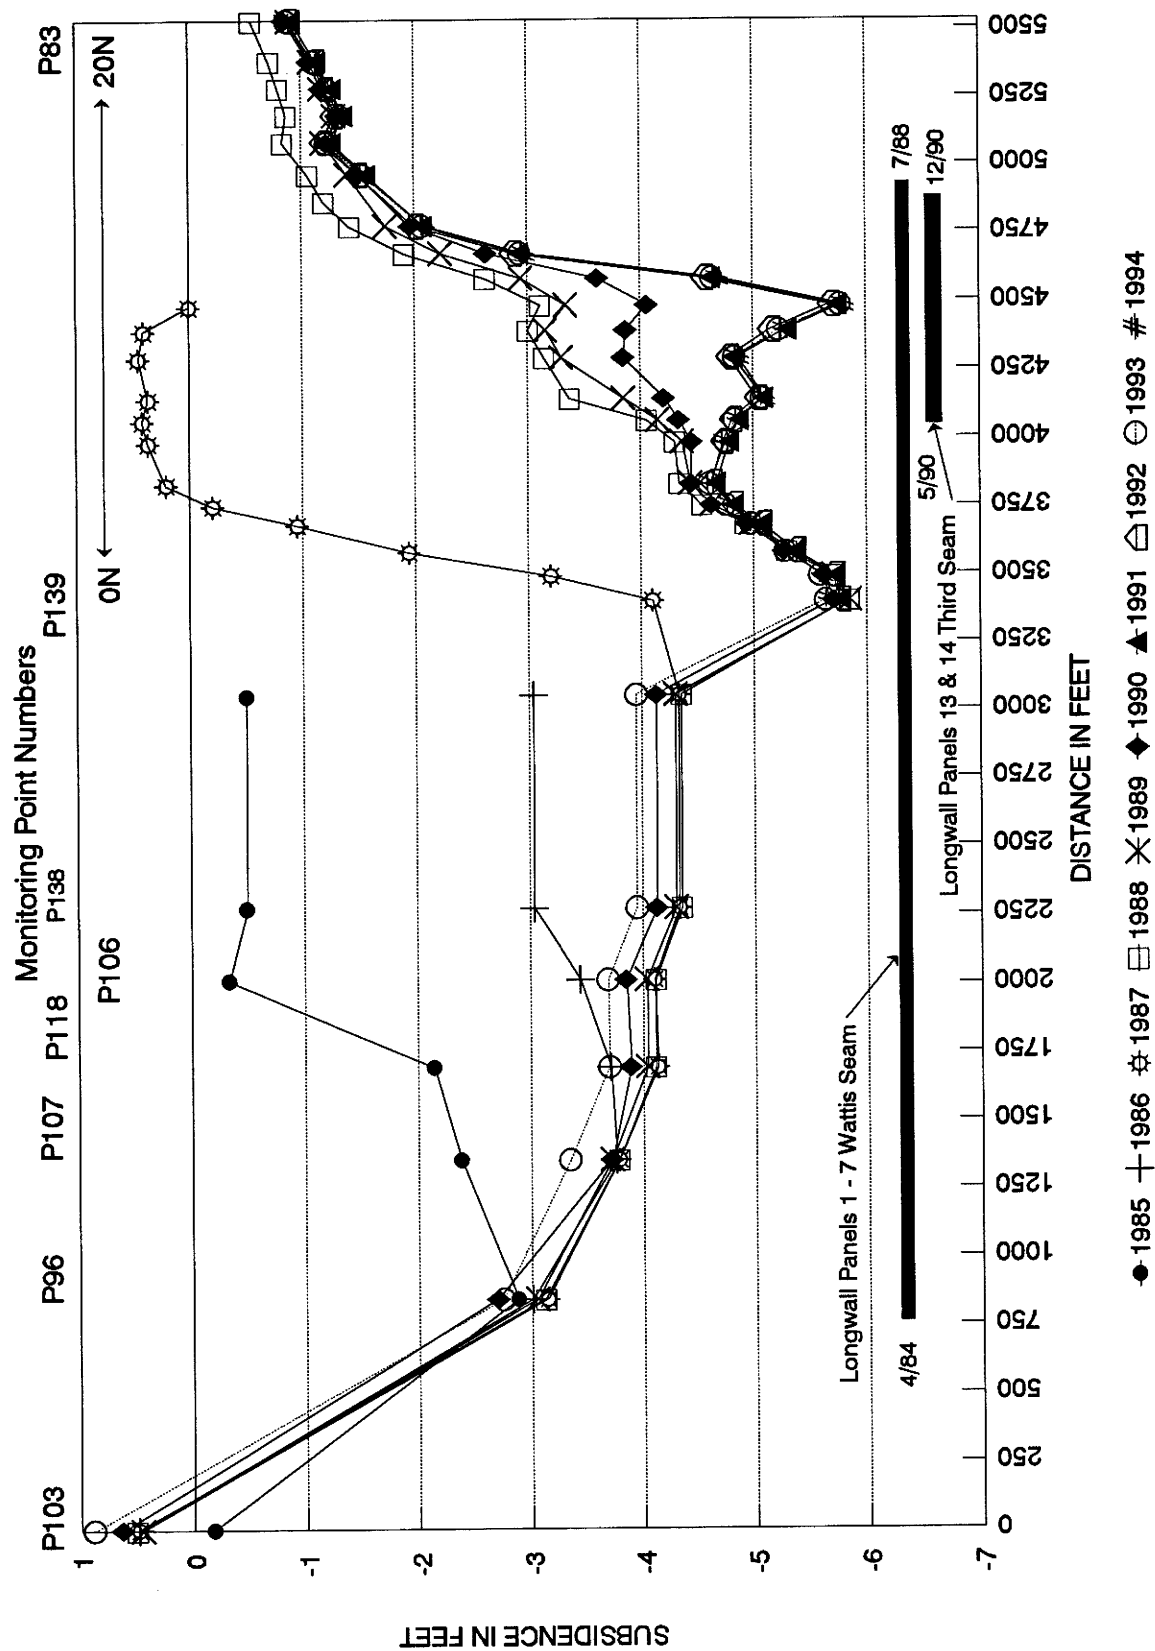
# FIGURE 1

Cross sections have been plotted through Panels 1-7, 13 and 14 (Figure 1), Panel 2 (Figure 2), and Panel 4 (Figure 3). Cross Section F-F has been plotted of monitoring points U-18 through U-32 (Figure 10) showing the angle of draw at this location of 15 degrees. Please refer to Map 521.121e for cross section locations.

As can be seen on Figures 1, 2, and 3, subsidence has stopped above the longwall panels in the area of longwall panels 1-7 and 13 and 14. Subsidence reached its maximum during the third year after mining. Figure 1 shows the subsidence profile diagonally through the nine longwall panels. The progression of subsidence can be seen to the north as successive panels were mined.

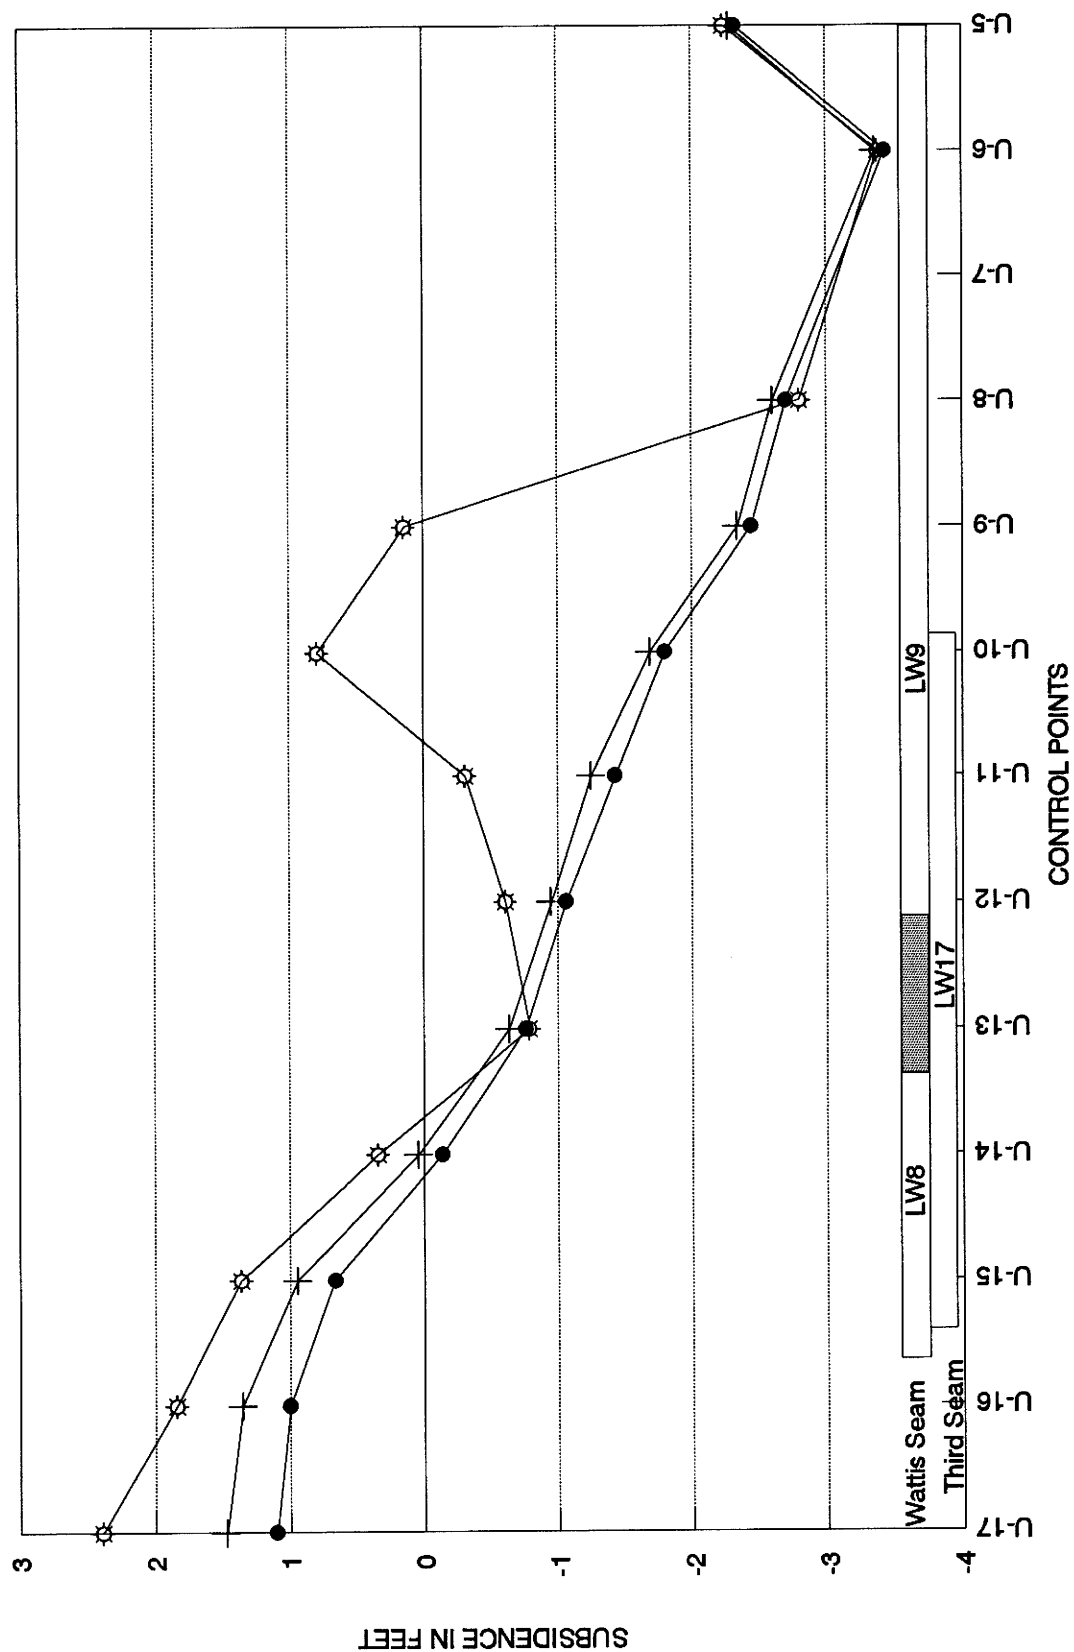
# FIGURE 4 U-NORTH NEAR-STREAM PROFILE

A cross section through Points U5-U17 in Section 18 (Figure 4) indicates a maximum vertical drop of 3.4 feet. These monitoring points were not monitored in 1991 due to hazardous conditions but, were monitored again in 1992. They were not monitored in 1993 due to hazardous conditions. As can be seen on the cross section, mining of longwall panels 16 and 17 in the Third Seam caused additional movement.

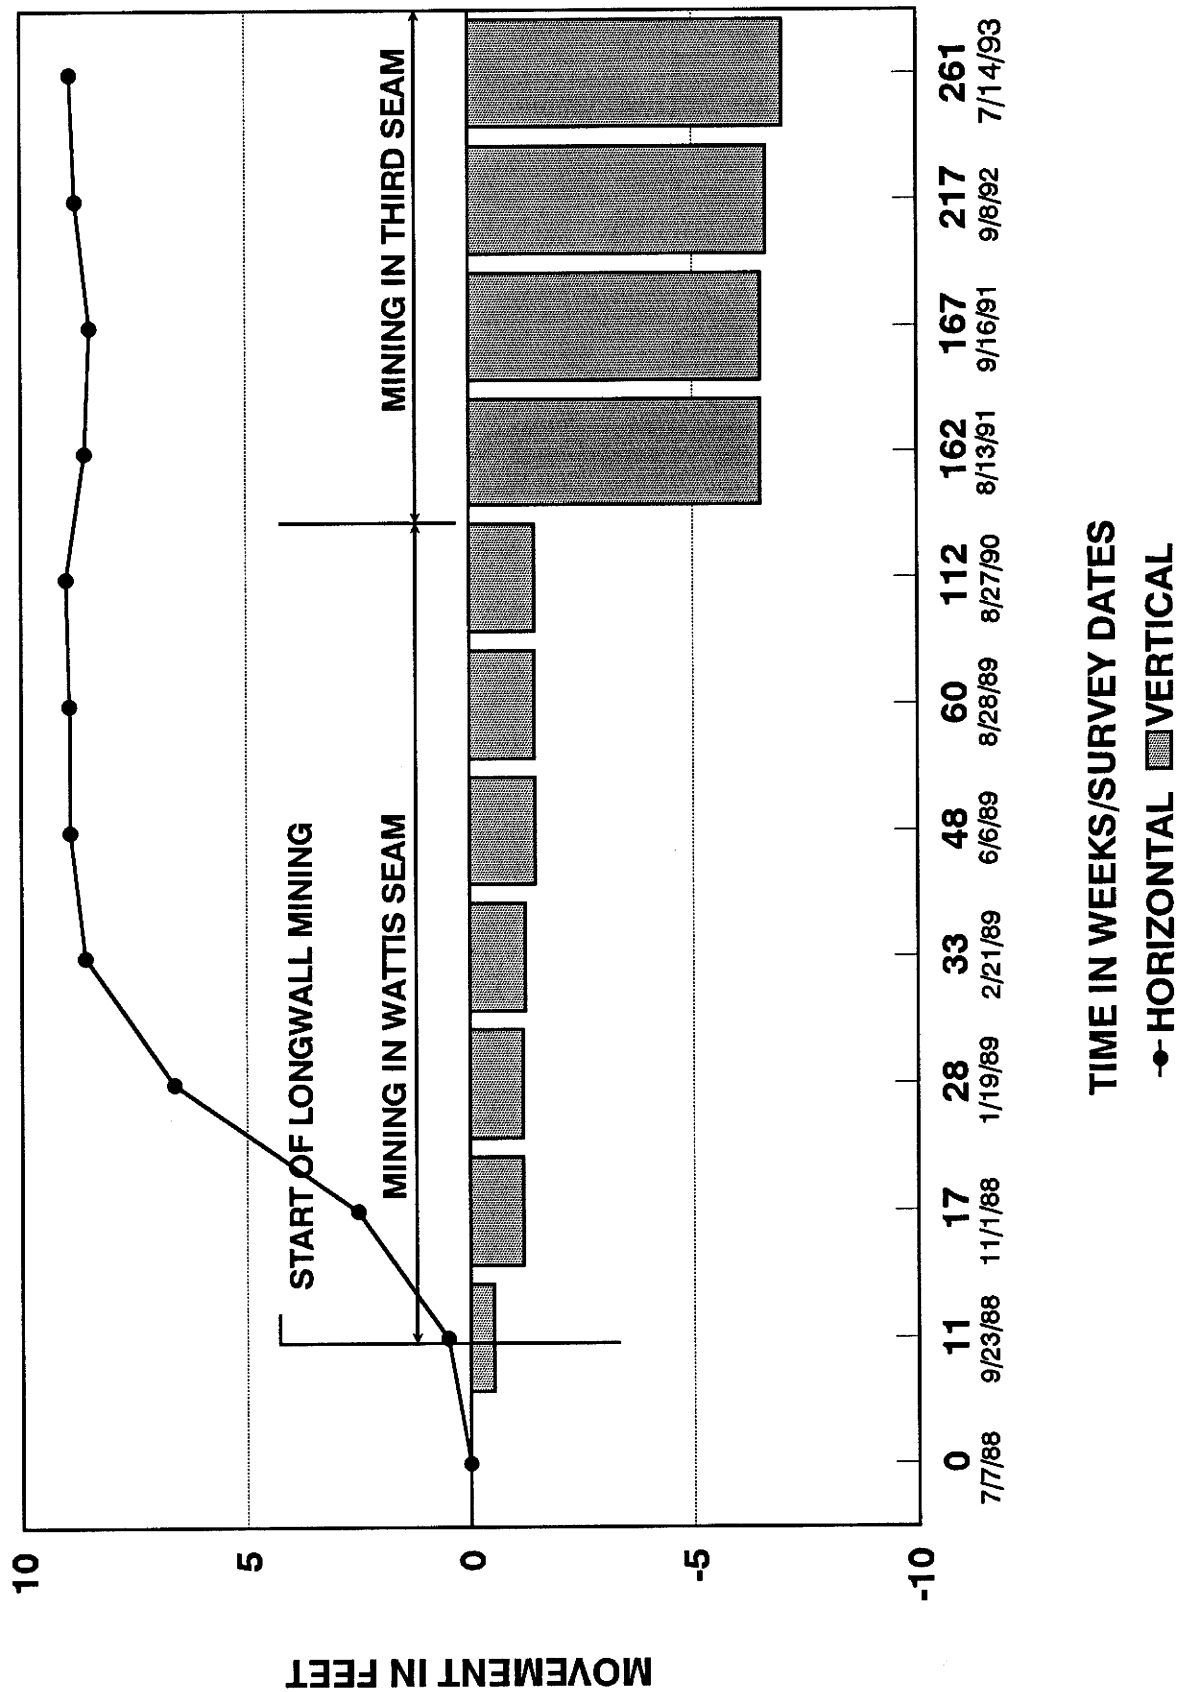
FIGURE 5  
U-NORTH SUBSIDENCE MONITORING  
HORIZONTAL AND VERTICAL MOVEMENT GRAPH  
STATION U1

Horizontal and vertical movement graphs have been made of monitoring points U1, U2, U3, and U4, Figures 5, 6, 7, and 8 respectively. Point U1, which is located directly above the north edge of longwall mining in the Wattis coal seam, shows the most vertical and horizontal movement. Point U4 which is located north of mining in the Wattis Seam and at the north edge of mining in the Third Seam shows the least movement.

A portion of the surface cracks near monitoring points U1 and U2 in Section 18 have been repaired to reduce the likelihood of accidents. The cracks were backfilled and the area fenced. Signs were placed in the area warning the public of the potential danger of the unstable ground. This area is fee land owned by the U.S. Fuel Company; Cyprus Plateau Mining Corporation has an agreement with U.S. Fuel which allows mining impacts. In the fall of 1995, the cracks were plugged with foam to provide additional protection to the public and provide a base for future backfilling.

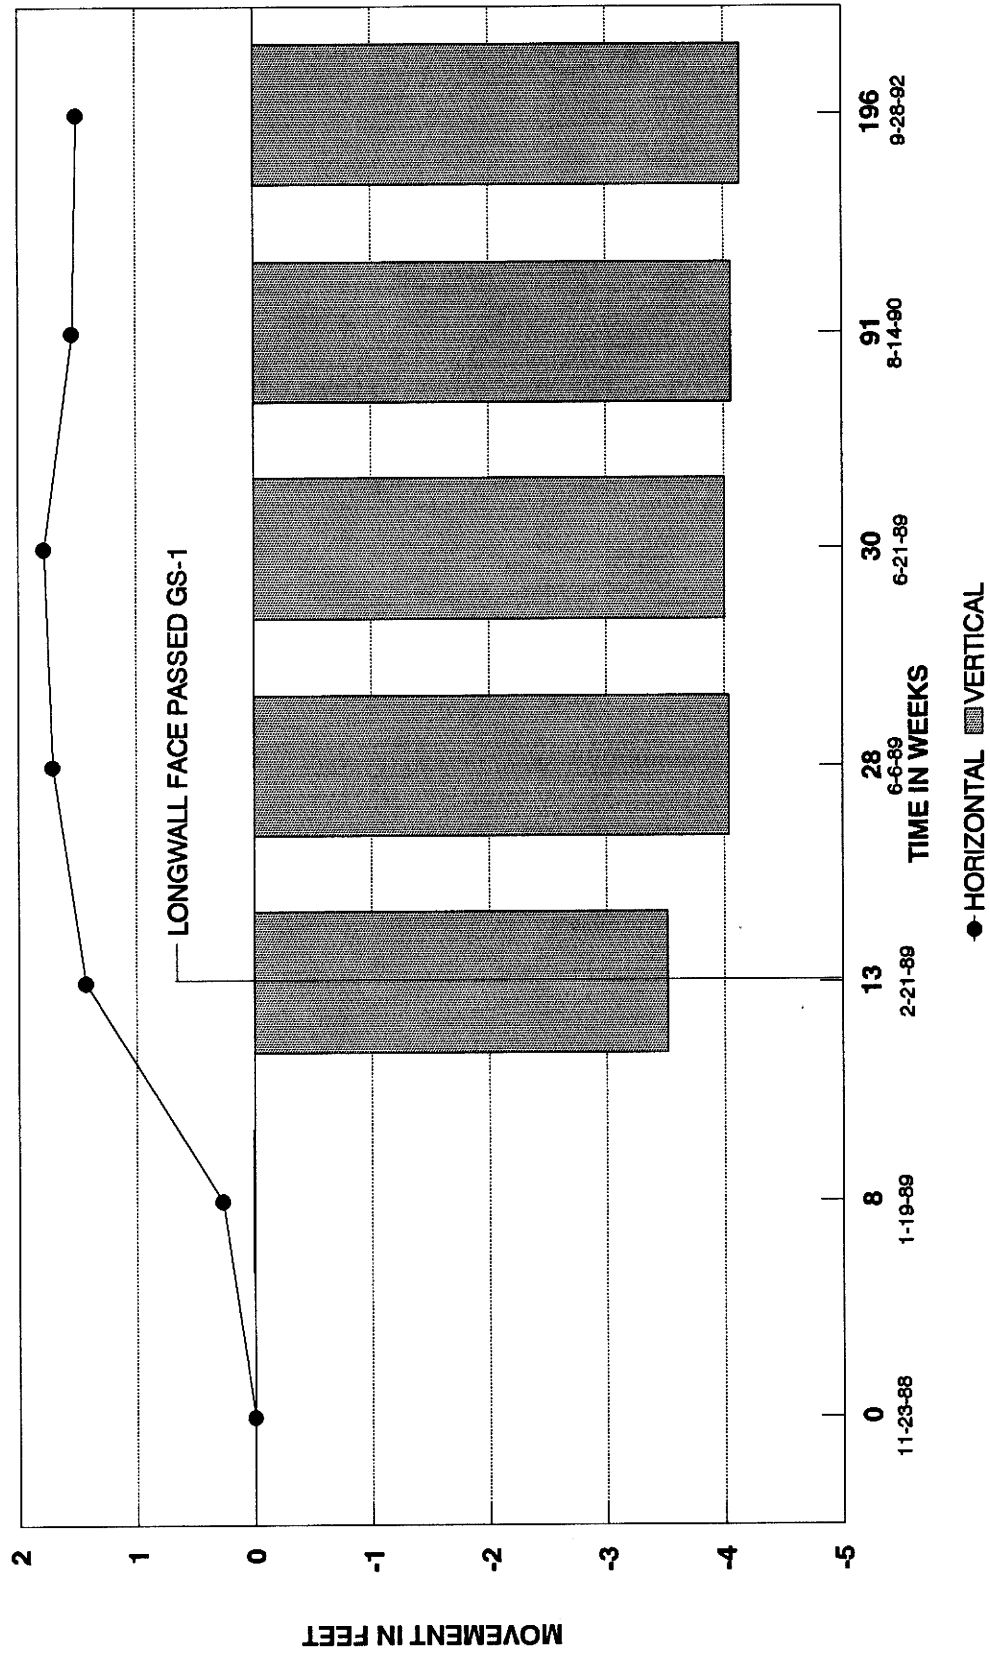
FIGURE 9  
STATION GS-1 U-NORTH  
HORIZONTAL AND VERTICAL MOVEMENT GRAPH

A horizontal and vertical movement graph (Figure 9) has been plotted of monitoring point GS-1 near the stream in Section 18. Probably because of the shallow overburden at the GS-1 point location, maximum subsidence occurred within 15 weeks of the longwall face passing the point. This monitoring point was not surveyed in 1991 and 1993 because of the hazardous condition previously discussed but, was surveyed in 1992. Mining of the Third seam was approximately 220 feet away and appears to have had only minor additional impact on this point.

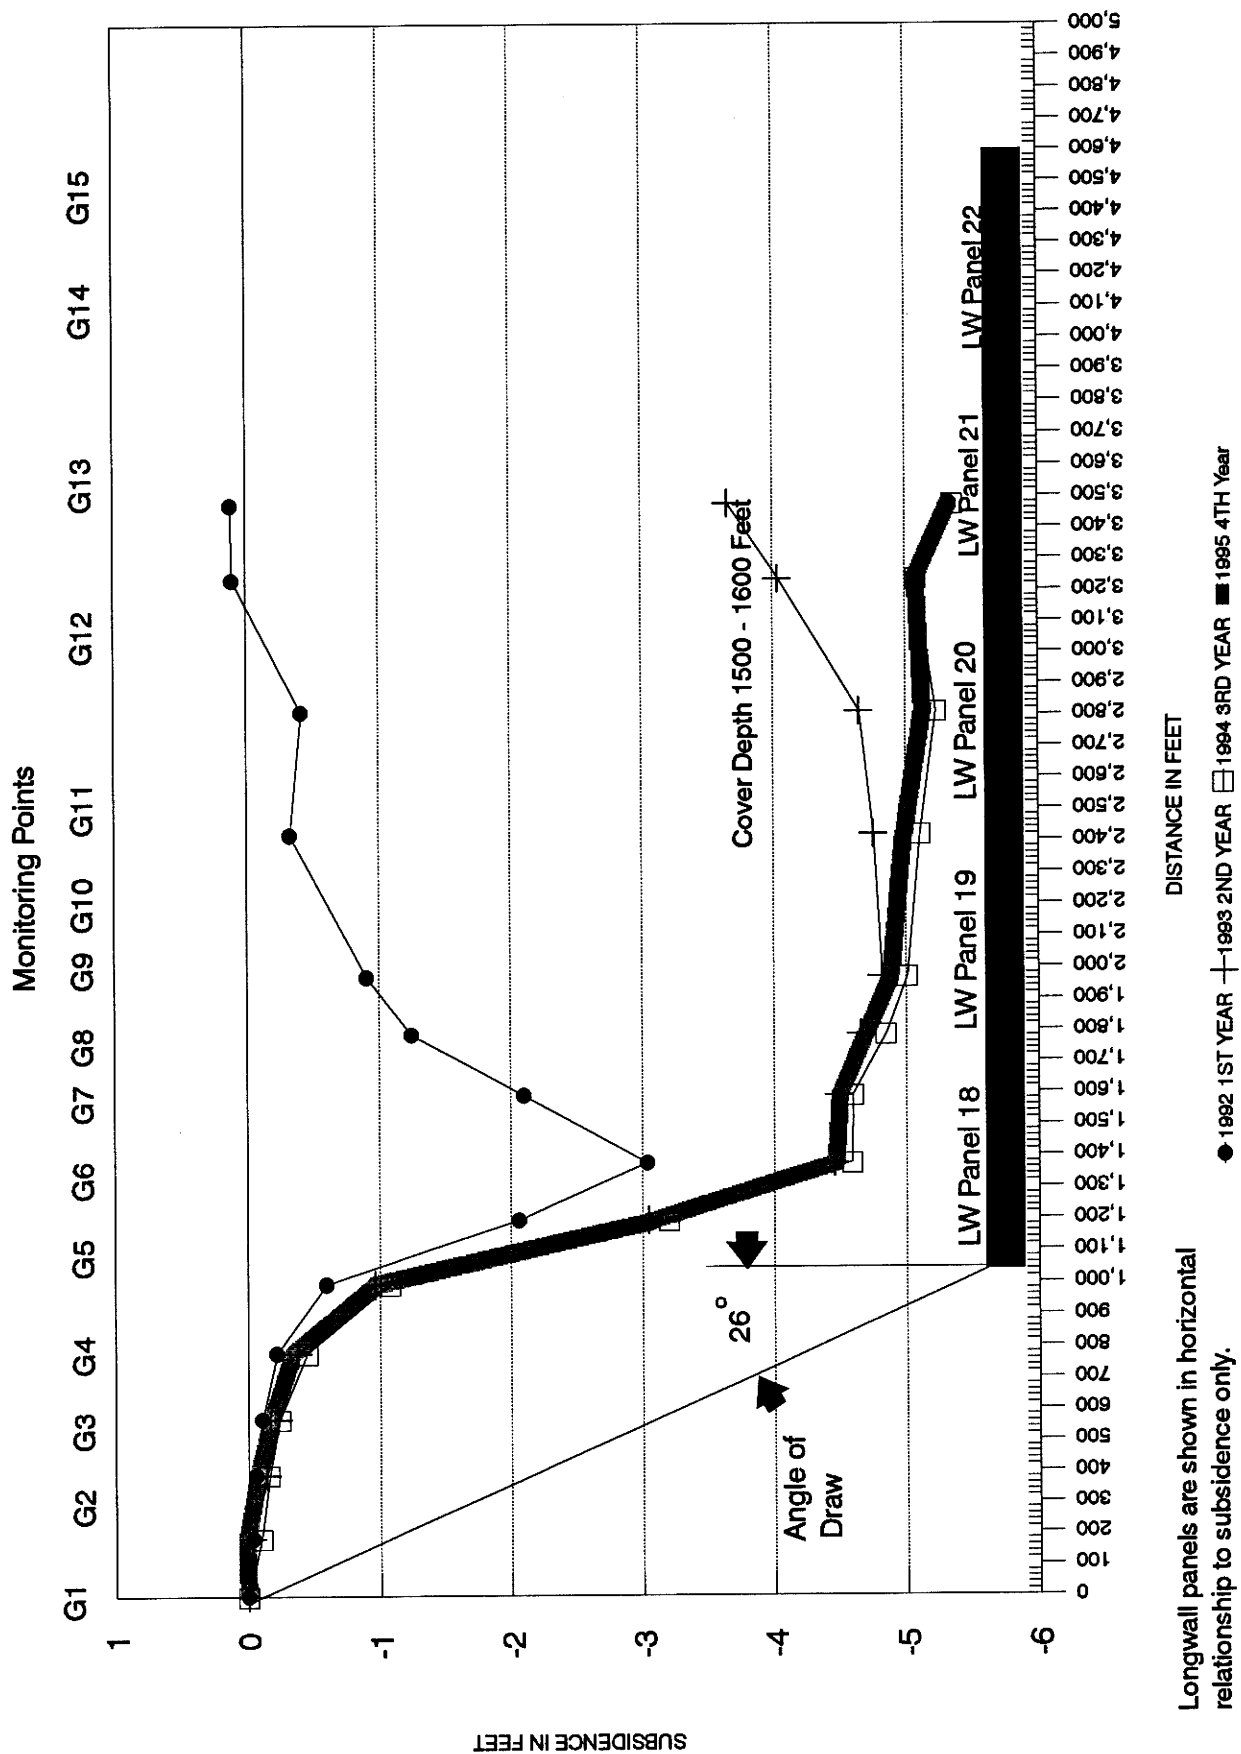
# FIGURE 11 CROSS SECTION D-D

Monitoring points G-1 through G-63 as shown on Map 521.121f were surveyed for vertical movement. Cross Sections D-D (Figure 11), E-E (Figure 12), G-G, and H-H were plotted from the data at these monitoring points. As can be seen on the cross sections, maximum subsidence is 5.33 feet at monitoring station G-15 feet. Subsidence at points Fox 2 and 3 is 5.50 feet.

As shown on Cross Sections D-D and E-E, the angle of draw at these locations is 26 degrees and 24 degrees respectively. Not enough data are available at Cross Sections G-G and H-H to calculate the angel of draws at these locations.
